FIRST INTERIM REPORT

ELEVATED TEMPERATURE STRESS CORROSION OF HIGH STRENGTH SHEET MATERIALS IN THE PRESENCE OF STRESS CONCENTRATORS

Contract NASr-50

November, 1964

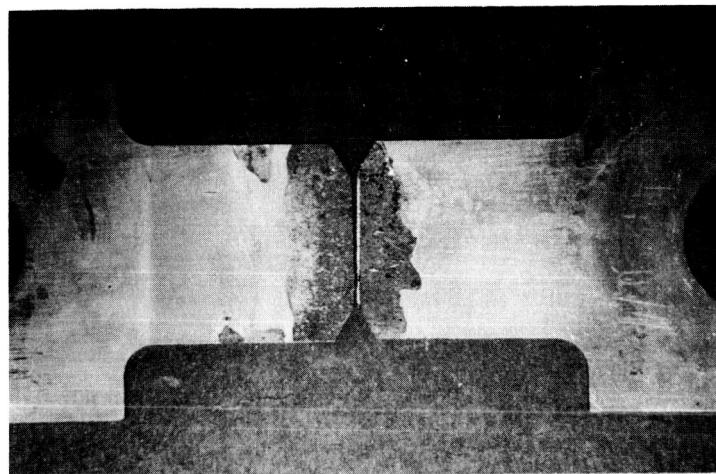
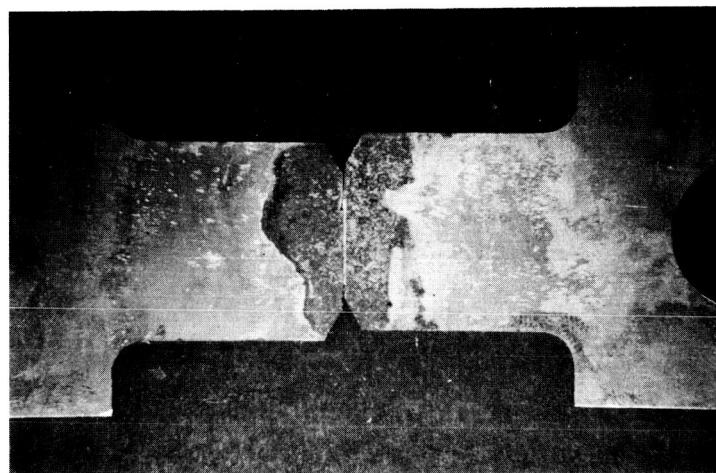
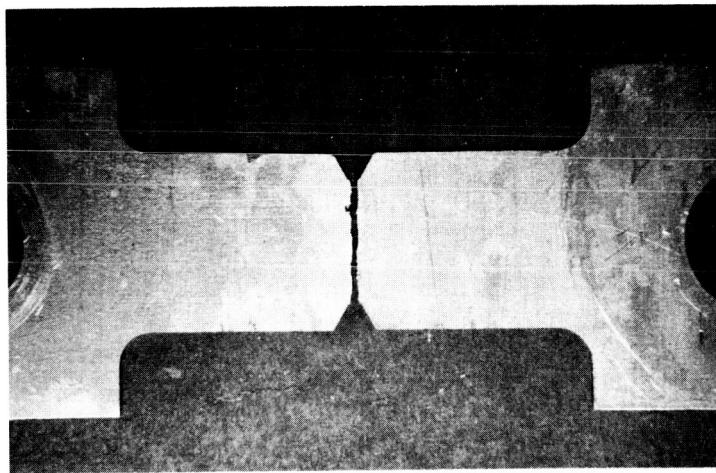
All of the notched stainless and superalloy samples fractured at the notch bottom. The steel and cobalt base alloys were stained by the salt layer, but the Inconel W was not, Fig. 10.

Fig. 10 SURFACE APPEARANCE OF EXPOSED SPECIMENS
AFTER SUBSEQUENT TENSILE TEST.

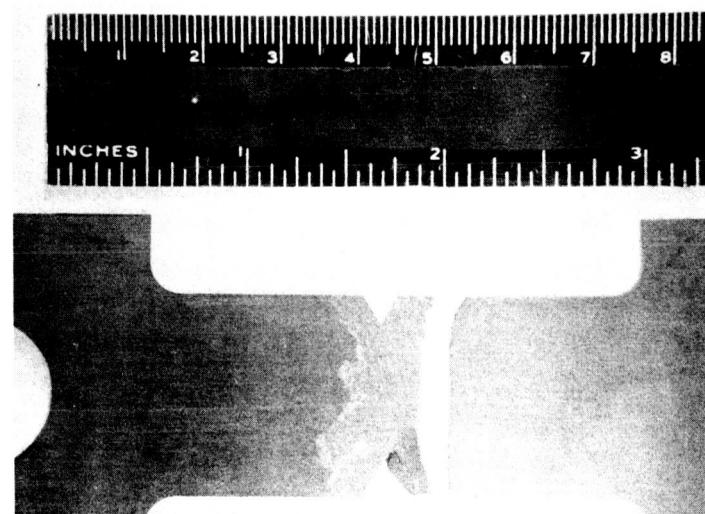
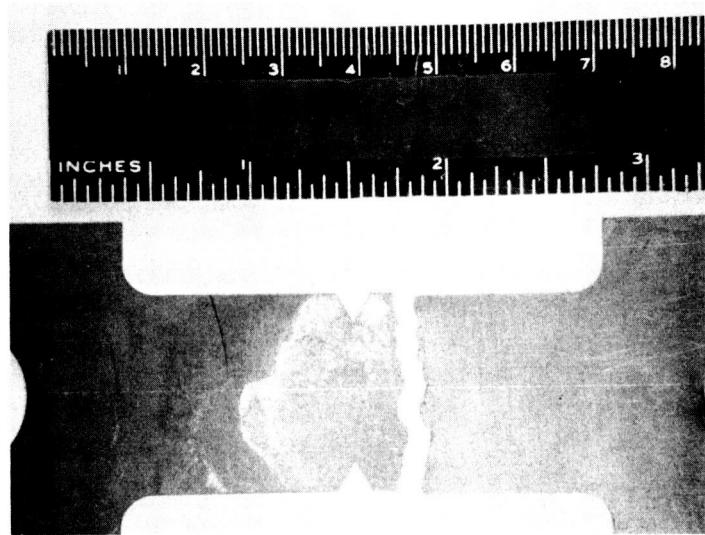
Surprisingly, fracture did not occur in the plane of the notch bottom where the nominal stress was 25 ksi (neglecting the stress concentrator of the 0.00025 inch radius notch). Instead failures occurred near the edge of the applied salt layer, Fig. 11, where the stress was only 70 percent of its maximum nominal value, i.e. 17.5 ksi. This sensitivity to cracking in the presence of sea-salt was greater than that reported for NaCl exposure (see Fig. 1).

Fig. 11 LOCATION OF FAILURE AND SURFACE APPEARANCE OF EXPOSED Ti-8Al-1Mo-1V SPECIMEN. TOP TRANSVERSE, BOTTOM LONGITUDINAL.

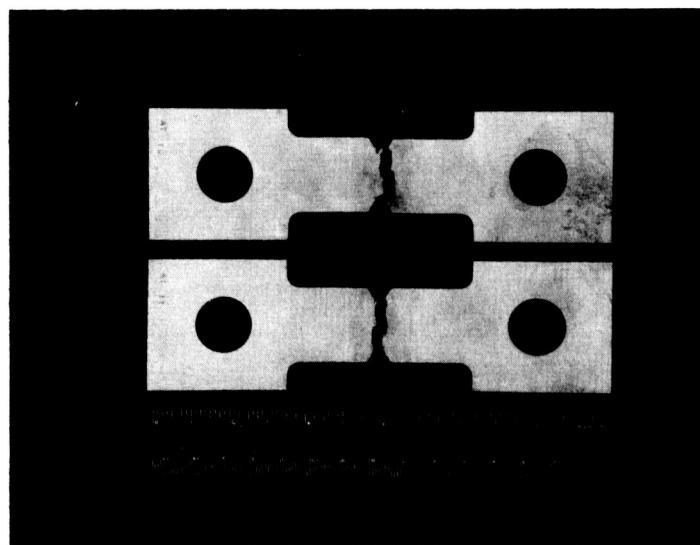
Fig. 24 FRACTURED Ti-6Al-4V NOTCH SAMPLES AFTER 650° F EXPOSURE TO SEA SALT AND AN EXTERNALLY APPLIED CURRENT.

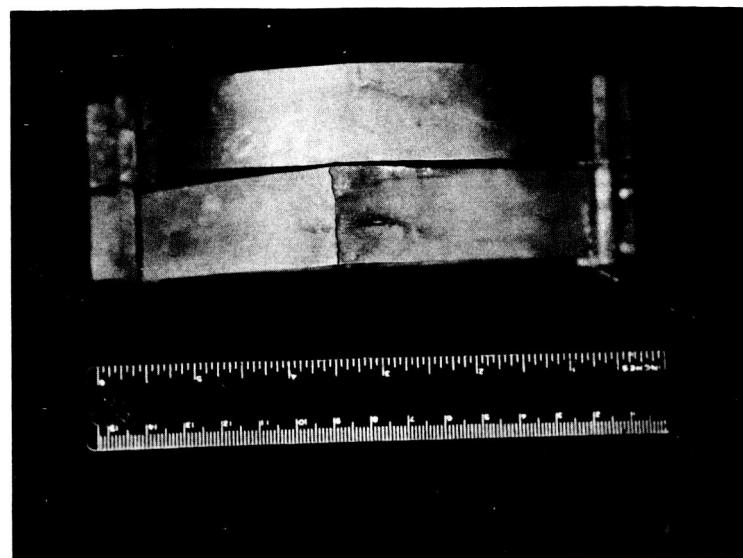
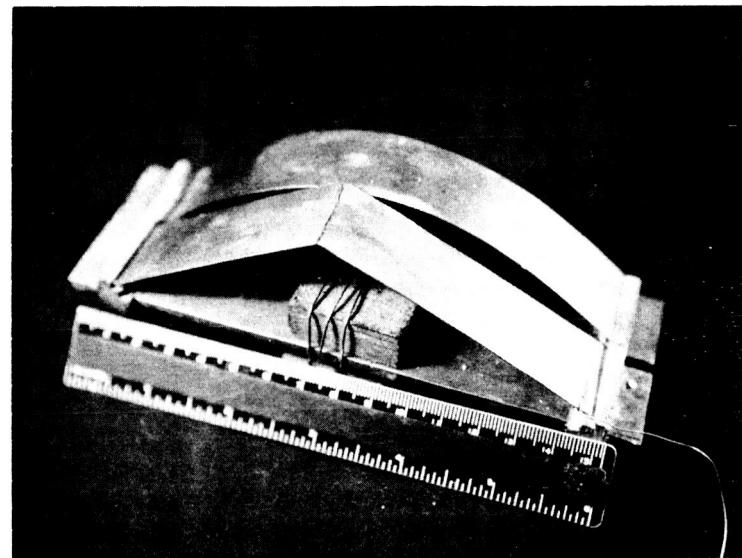
Fig 29 CONDITION OF BEND SAMPLES AFTER REMOVAL FROM CORROSION CELL. CONTROL SAMPLE IS IN REAR, COUPLED SAMPLE IS IN FOREGROUND.
(a) TOP VIEW, (b) OBLIQUE VIEW.

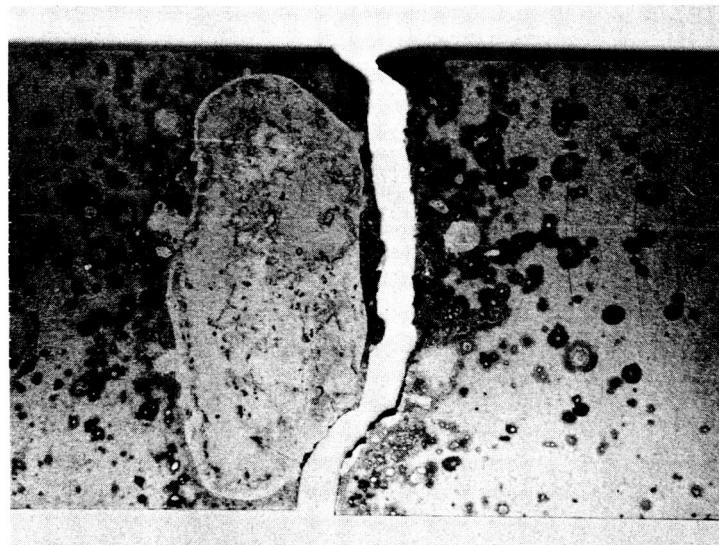
Fig. 30 STRESS CORROSION CRACK AT LIQUID SALT EDGE.
SAMPLE WAS STRESS TO 80 KSI BY BENDING.
FAILURE OCCURRED AFTER 28 MINUTES AT 690°F
AND $\text{pp O}_2 = 1 \times 10^{-5}$ mm Hg.

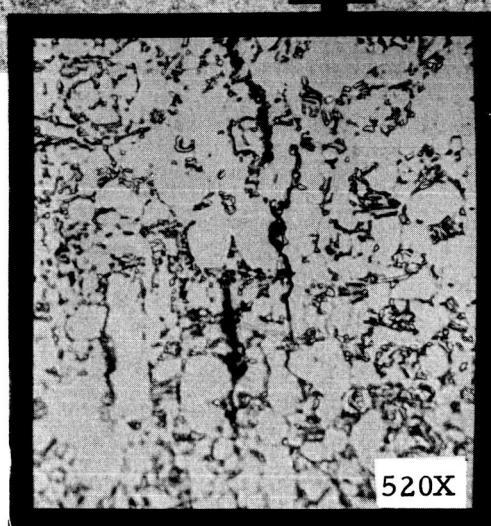
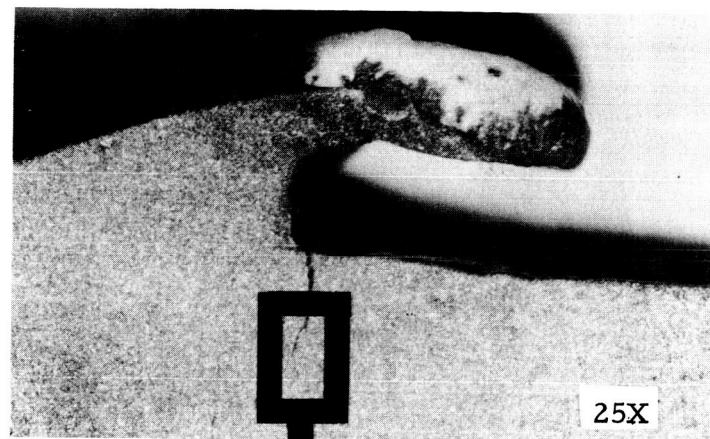
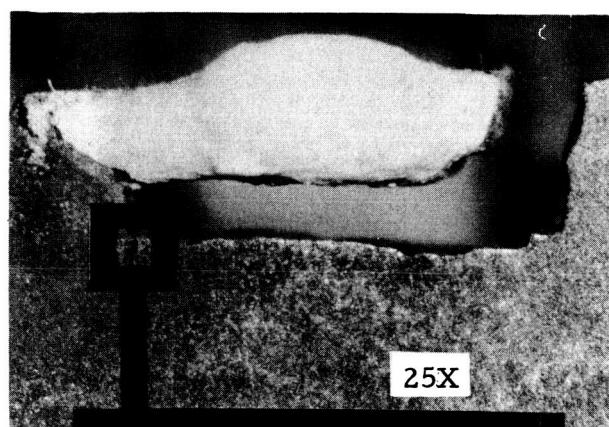
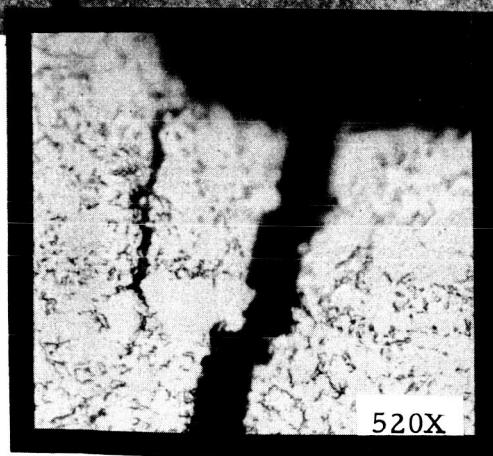
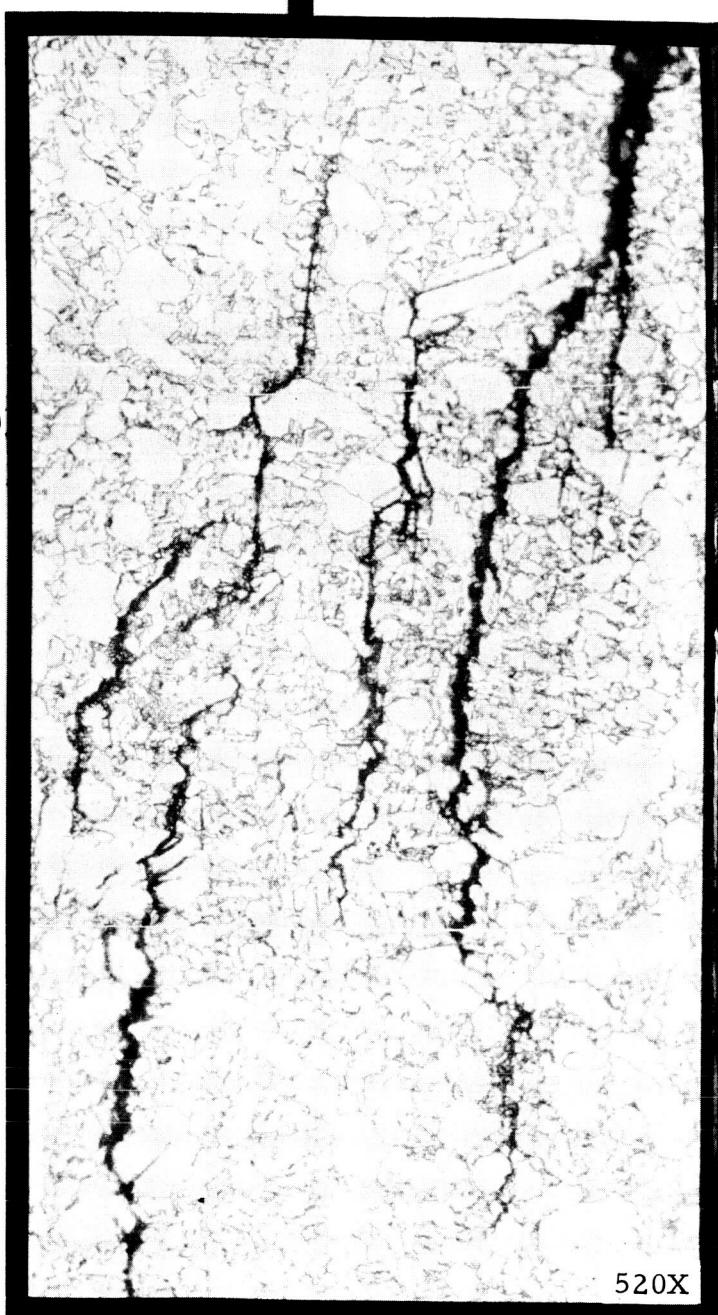
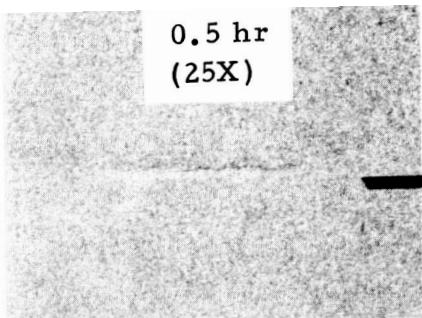
Fig. 38 STRESS CORROSION CRACKS IN Ti-6Al-4V.
EXPOSED AT 650° F, 80 KSI FOR (a) 200 HR,
(b) 200 HR, AND (c) 100 HR.

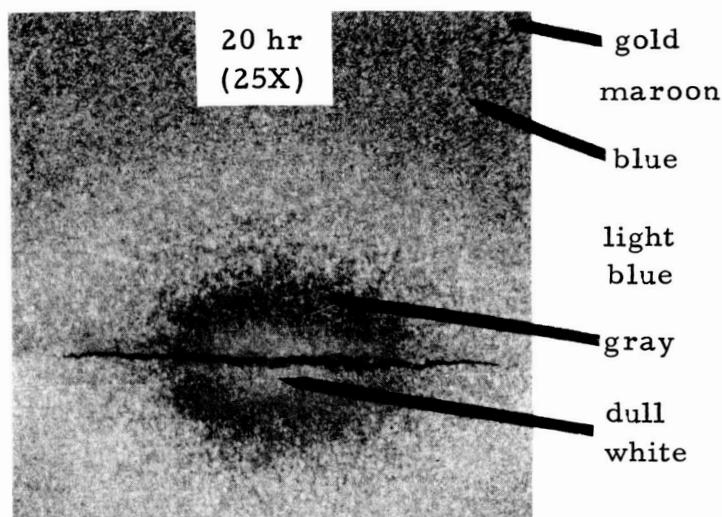
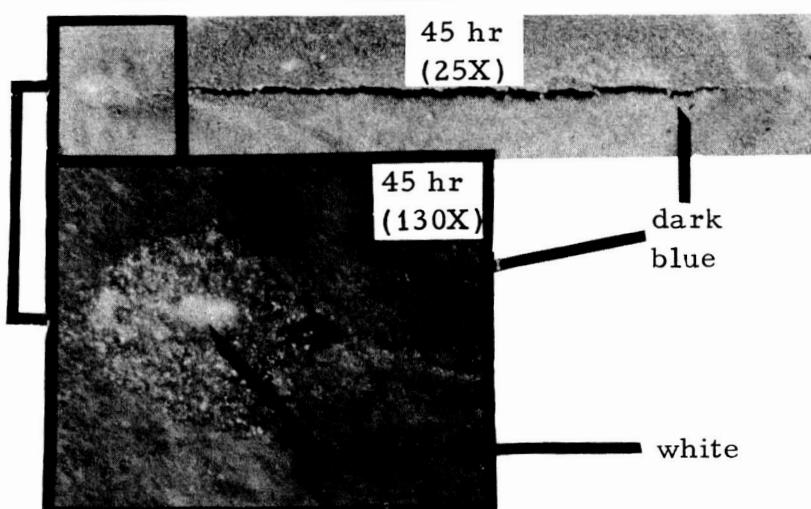
First indication of cracking. No color variation present and no indication of corrosion products. Temp maintained at 650F, stress 60 ksi. The salt is on the opposite side of the sample.

Waves of corrosion product emanating concentrically from crack in elliptical pattern. Stress dropped to 52 ksi; temp still 650F. The crack was apparently empty.

Temperature raised to 1120F for 15 minutes, then lowered to R.T. A liquid was seen at this temperature and the evidence of it is shown in these photographs taken at R.T. The liquid has migrated, by capillary action, to the most narrow regions of the crack, and has oozed out at the crack tip.

Fig. 39 DEVELOPMENT OF CRACK AND CORROSION PRODUCTS IN Ti-6Al-4V.

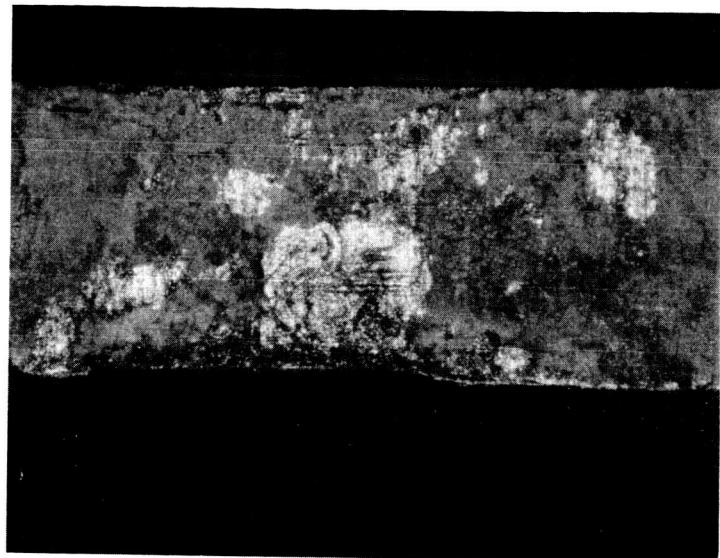
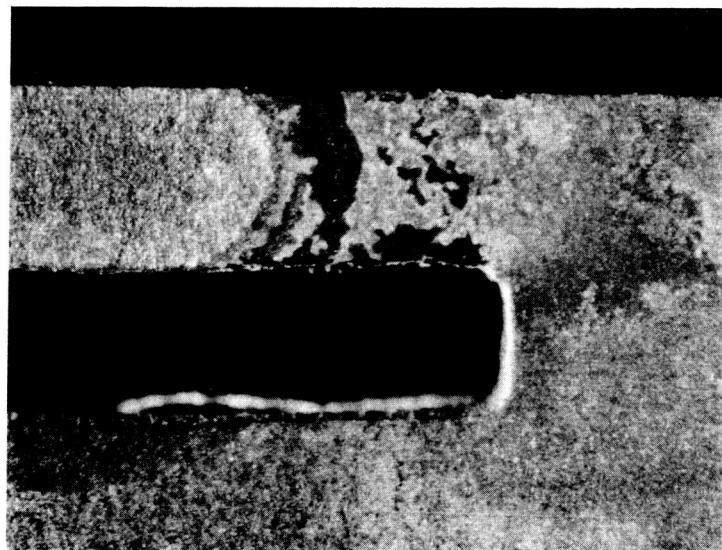
Fig. 40 PHOTOGRAPHS SHOWING CORRODED AREA OF
A Ti-6Al-4V PRONGED SAMPLE AFTER EXPOSURE
TO SEA SALT AT 650°F FOR 200 HR.
